Subsurface Investigation of

Petroleum Contamination at

Thompson's Garage

Woodstock, Vermont

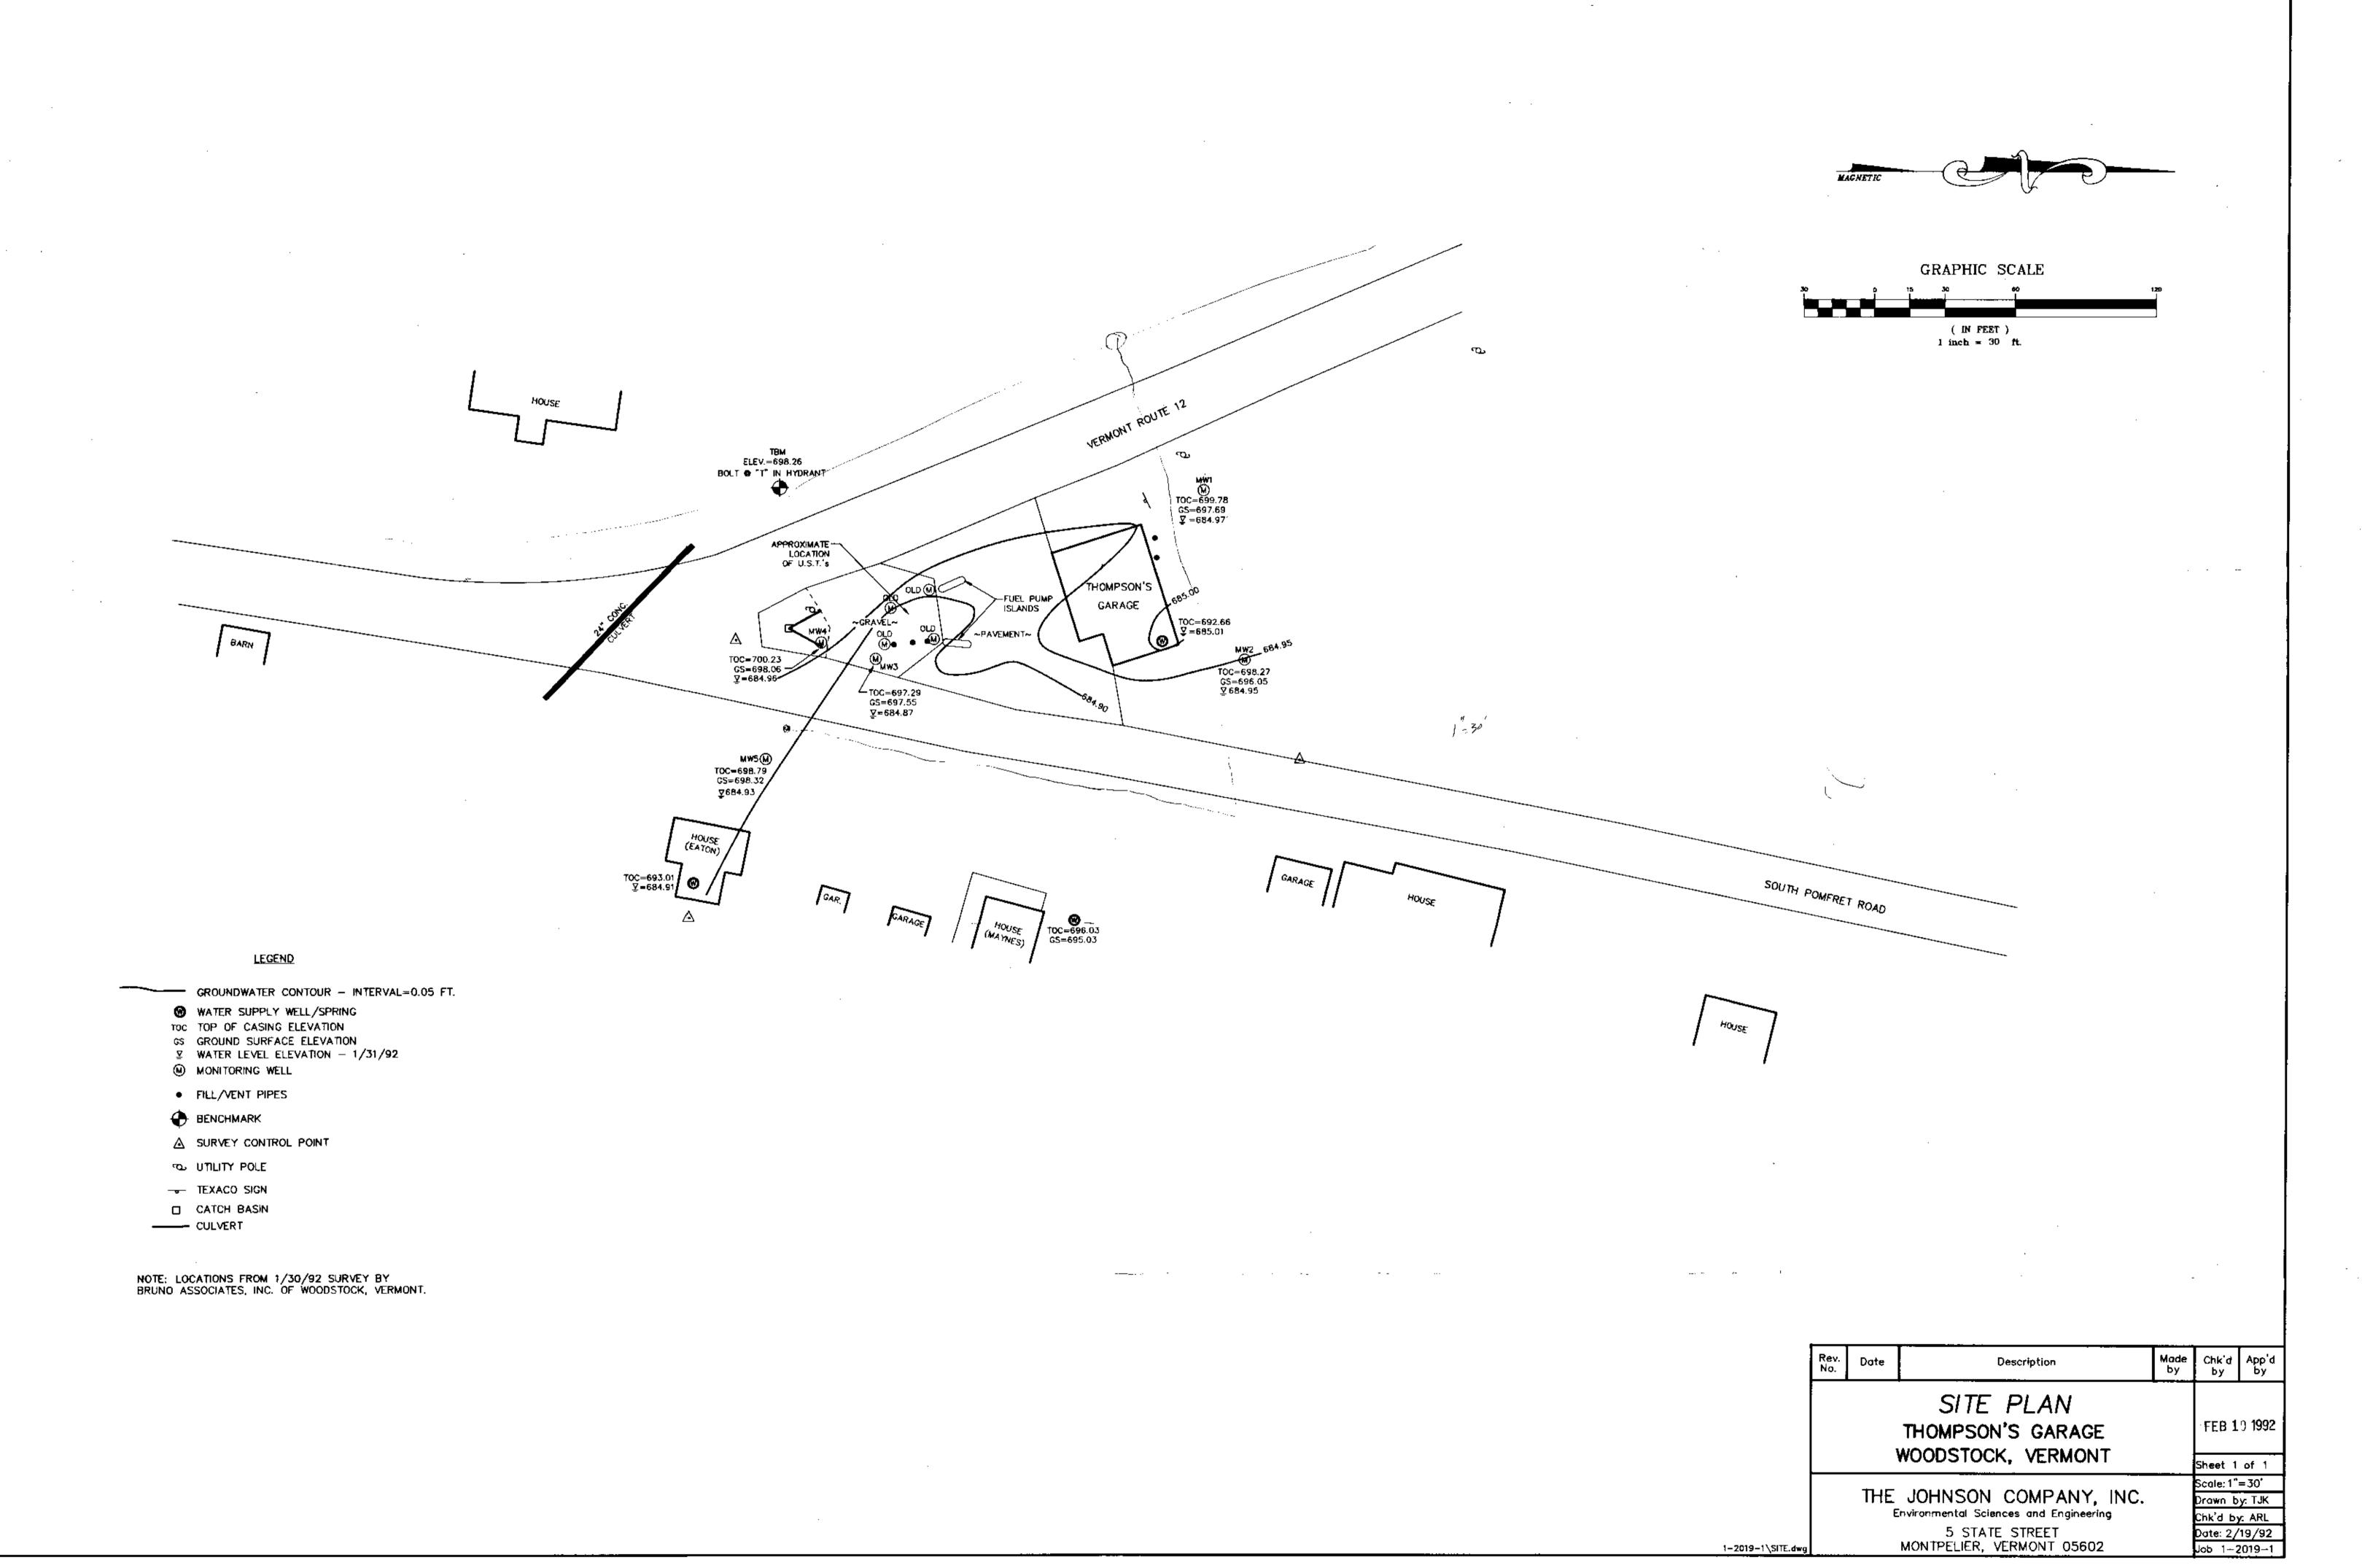
Attachment 1 Site Plan

The water table contours presented on the Site Plan, Attachment 1, are based upon the water level measurements taken on January 31, 1992. The water level measurements taken on January 16 produce a similar water table configuration to the January 31 results.

The apparent configuration of the water table on January 31 was of a general slope toward the southeast, with a slight trough and ridge both trending about north 20° west, and positioned beneath the gasoline tanks and the paved area, respectively. Assuming that groundwater flow in the uppermost aquifer is normal to the equipotential lines depicted on Attachment 1, then the predicted direction of groundwater flow in the uppermost aquifer beneath the garage is in a southeasterly direction, towards the Eaton residence, with local variations induced by the previously-referenced trough and ridge.
